POTOMAC RIVER BASIN
CARBAUGH RUN DAM
SOUTH MOUNTAIN RESTORATION CENTER
NDI NO. PA-00881
DER NO. I-077
ADAMS COUNTY, PENNSYLVANIA
PHASE I INSPECTION REPORT
NATIONAL DAM INSPECTION PROGRAM

PHASE I REPORT
NATIONAL DAM INSPECTION PROGRAM

Name of Dam: CARBAUGH RUN DAM
State & State No.: PENNSYLVANIA, 1-077
County: ADAMS
Stream: CARBAUGH RUN
Date of Inspection: October 10, 1980

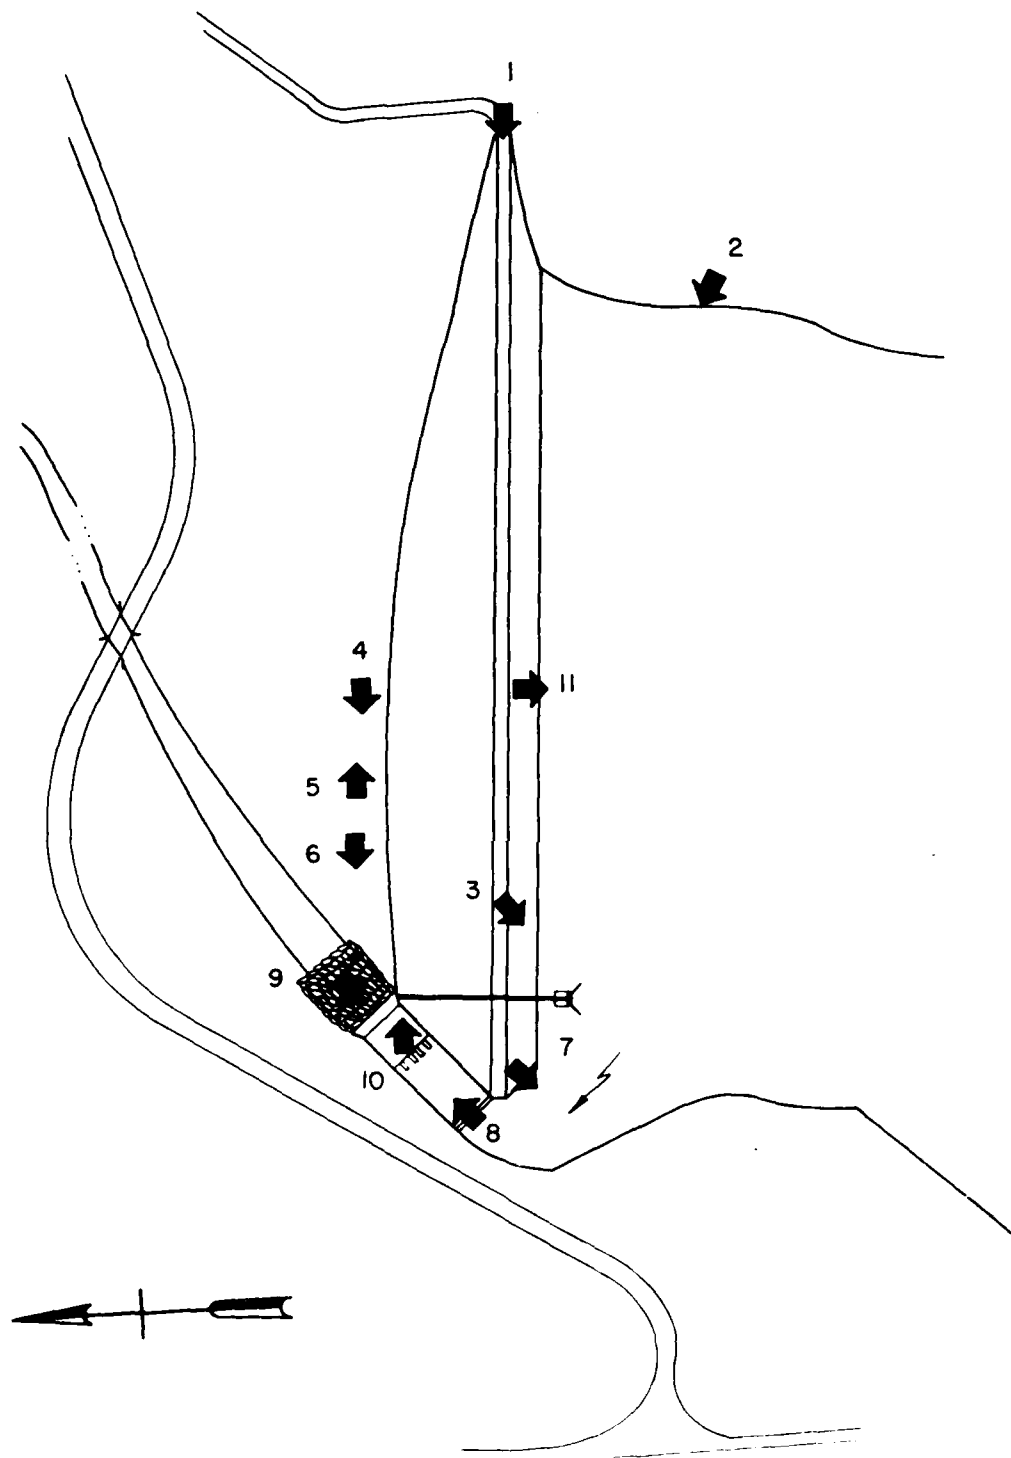
CARBAUGH RUN DAM
PA - 00881
KEY MAP OF PHOTOGRAPHS
PLATE C-I

A twenty foot wide area at the downstream toe has been cleared of trees and brush (Photographs No. 4 and No. 5). This area is flat, wet and swampy over most of its length. Pools of standing water are located close to the stilling basin (Photograph No. 6). This condition is probably caused by seepage and is accentuated due to the poor drainage conditions adjacent to the downstream toe. There was no noticeable flow of water.

The intake control tower (Photograph No. 3) is located close to the spillway forebay area at the upstream toe. There are three gate operator stands on the platform. One gate controls the flow through the 60-inch diameter outlet pipe. This 24-inch gate is generally slightly open to meet the minimum downstream flow criteria. The other two gates control the water supply intake. The tower appears to be in good condition with a slight deterioration of the concrete at the normal pool level. Access to the tower is by a footbridge from the crest of the dam. A 2.5-inch displacement was noticed at the bearing of the bridge at the abutment. This condition is not considered serious. The abutment is constructed on the fill and it is possible that the abutment has moved. The 60-inch diameter outlet pipe terminates in the stilling basin.

The spillway is located in the left abutment. The forebay is formed by two concrete wingwalls and a steep rock cut at the left side (Photograph No. 7). The spillway crest is angled upstream to the centerline of the dam. The spillway discharge channel is formed by concrete walls and a concrete slab (Photograph No. 9). Energy dissipating blocks are located at the end of the spillway chute and the concrete walls and slab are extended beyond these blocks. Weep holes are located in the slab and the left wall. All concrete of the spillway and discharge channel is in good condition. There were no signs of cracks or wall movements. Considerable seepage was noticed through the joint between the right wall and the slab beyond the energy dissipation blocks (Photograph No. 10). Rust coloring of the wall and some deterioration of the concrete at the joint indicates possible future problems with the stability of this wall section.
